**PHASE 2, STRUCTURAL ASSESSMENT**

**CITY OF NORTH PORT  
WORK AUTHORIZATION 8, PHASE 2  
PROJECT WM16HD**

**Prepared for: The City of North Port**

**September 30, 2016**

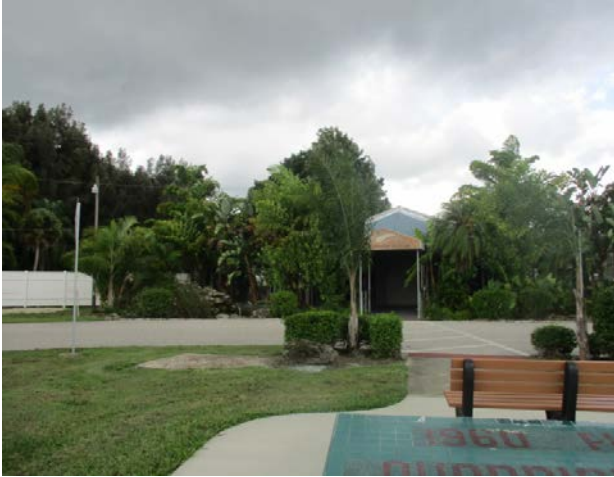
**Picture 1**  
Building 1 - Front Entry with Vegetation

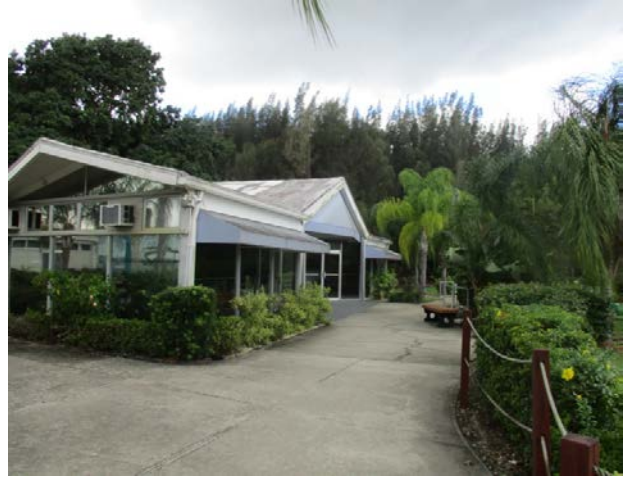
**Picture 2**  
Building 2 - NE Corner at Restaurant Area. Electric & Mechanical

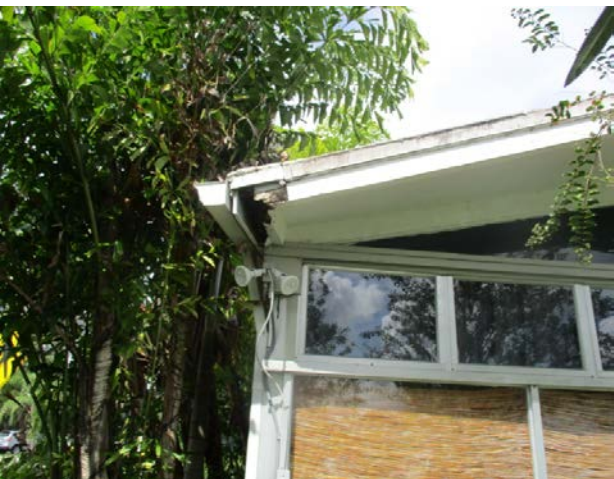
Timber roof joists are spaced on 4 foot centers. They support a plywood deck with a built up roof section of unknown composition. In our opinion, the roof condition is the controlling element in rehabilitating and renovating this structure as well as Building 2. There is extensive decay within the roof system of moderate to severe magnitude. Evidence of rot and decay at roof valleys is prevalent. Roof scuppers are in such disrepair that water is impounded and appears incapable of completely drying out. We believe that the decay exists over more than 20 percent of the roof deck which has been covered with insulated sealant. Coatings to the roof deck are evident. An analysis or determination of the roof deck coating material has not been performed. The magnitude of decay at the eaves and valleys make removal of the entire roof system probable under any scenario of restoration or renovation. Roof structural members appear in good condition with the exception of units above the restroom and changing facilities.

**Picture 5**  
Building 1 - Deteriorated Roof Soffit at SE Corner

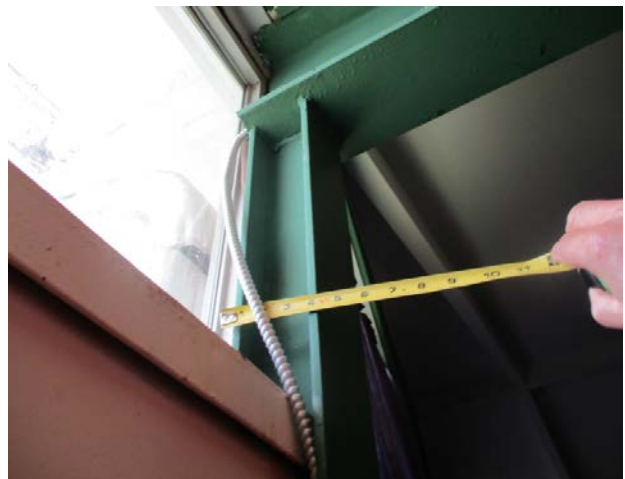
**Picture 6**  
Building 1 - 4" Column with Wall & Beam Connection

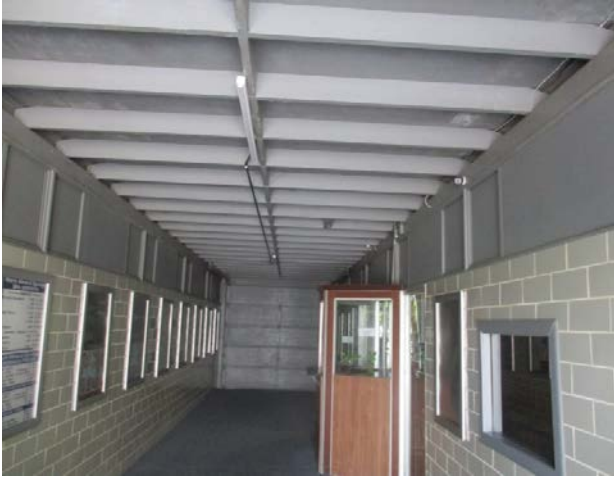
**Picture 7**  
Building 1 - Breezeway with Timber Rafters

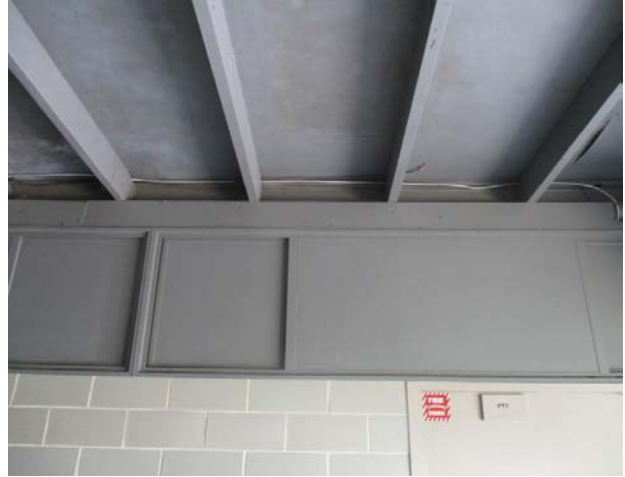
**Picture 8**  
Building 1 - Breezeway with Wood Fill Where Glass Existed

- 9 Replace all aluminum window frames and glass above 4 inch block. Includes areas now covered with wood.
- 10 Replace all aluminum frames and windows at corners of building

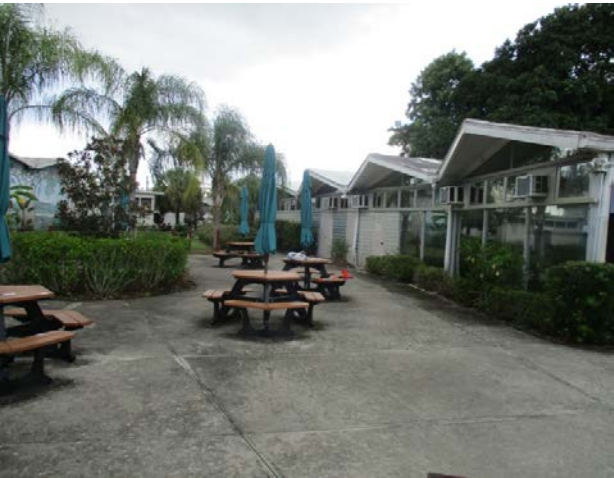
**Picture 9**  
Building 2 - Dormer Sections from NE Looking SW

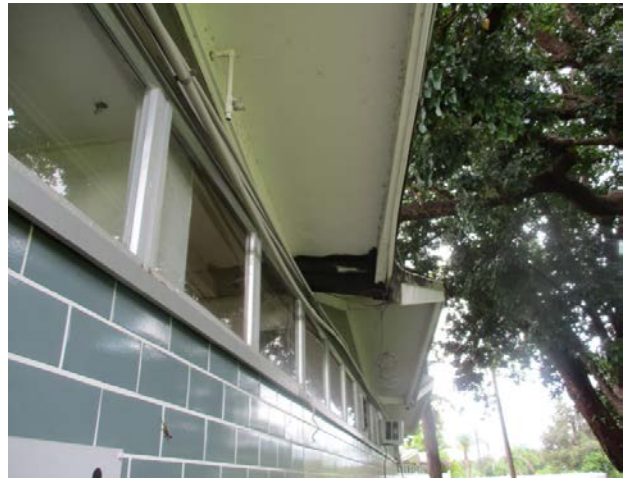
**Picture 10**  
Building 2 - Type 1 & 2 Windows with Aluminum Frame

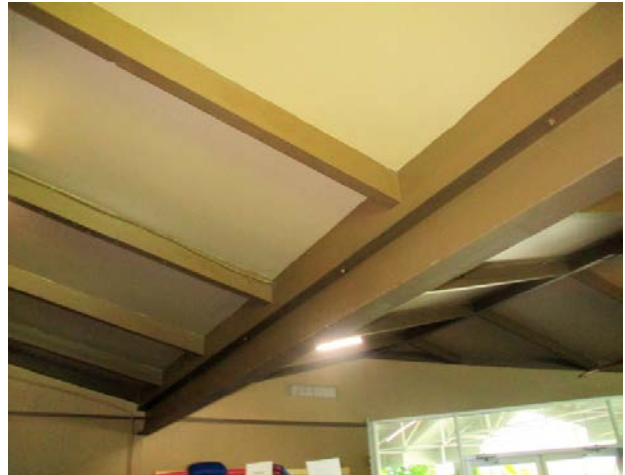
**Picture 12**  
Building 1 - Typical Beam, Girder & Roof Deck Configuration

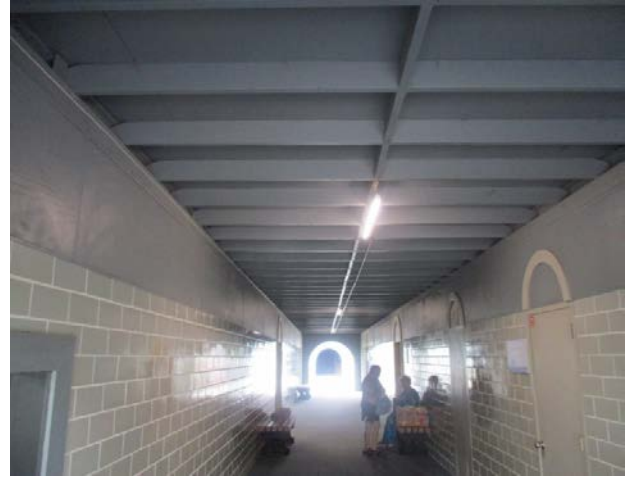
**Picture 14**  
Building 2 - Breezeway Looking South. Ceiling Joists.

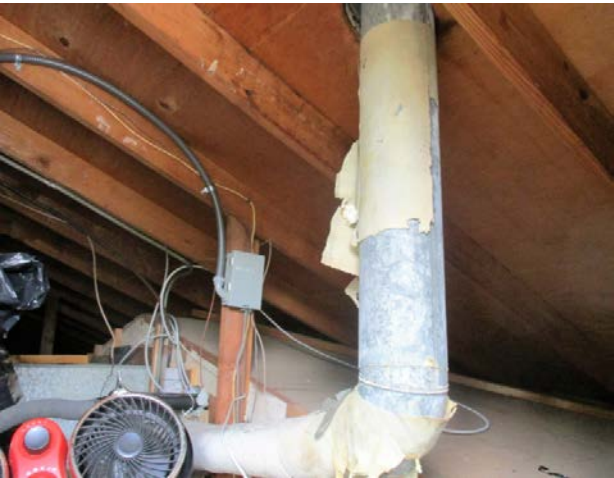
**Picture 15**  
Building 1 - Center Section & Support on Side Roof Deck

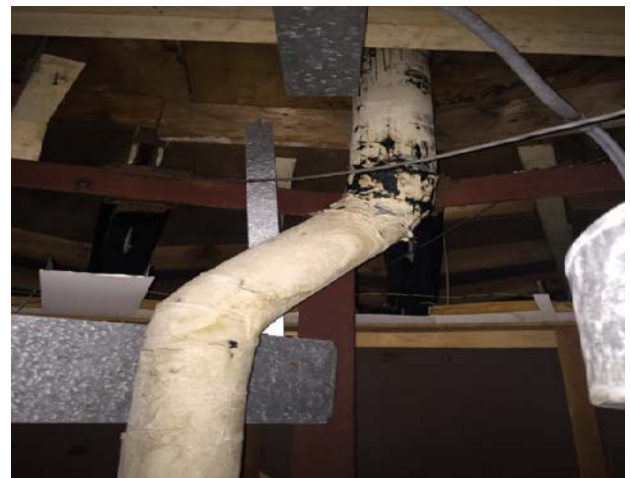
**Picture 16**  
Building 3 - Cyclorama Steel Collar & Support for Bar Joists

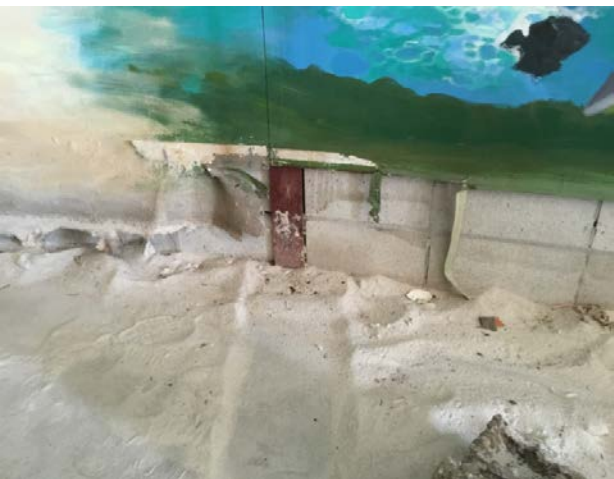
**Picture 17**  
Building 3 - Cyclorama Steel Column in Wall

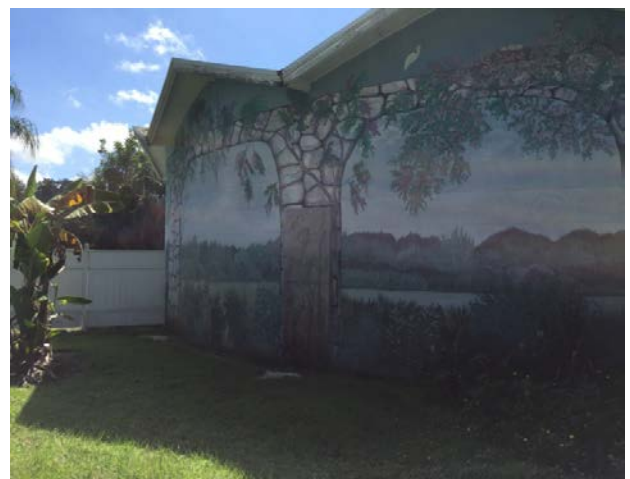
**Picture 18**  
Building 3 - Cyclorama Stucco
